# **Five-Year Review Report**

**Commencement Bay  
South Tacoma Channel Superfund Sites  
Tacoma, Washington**

**Third Five-Year Review Report for  
Well 12A (OU 1/2/3)**

**September 2008**

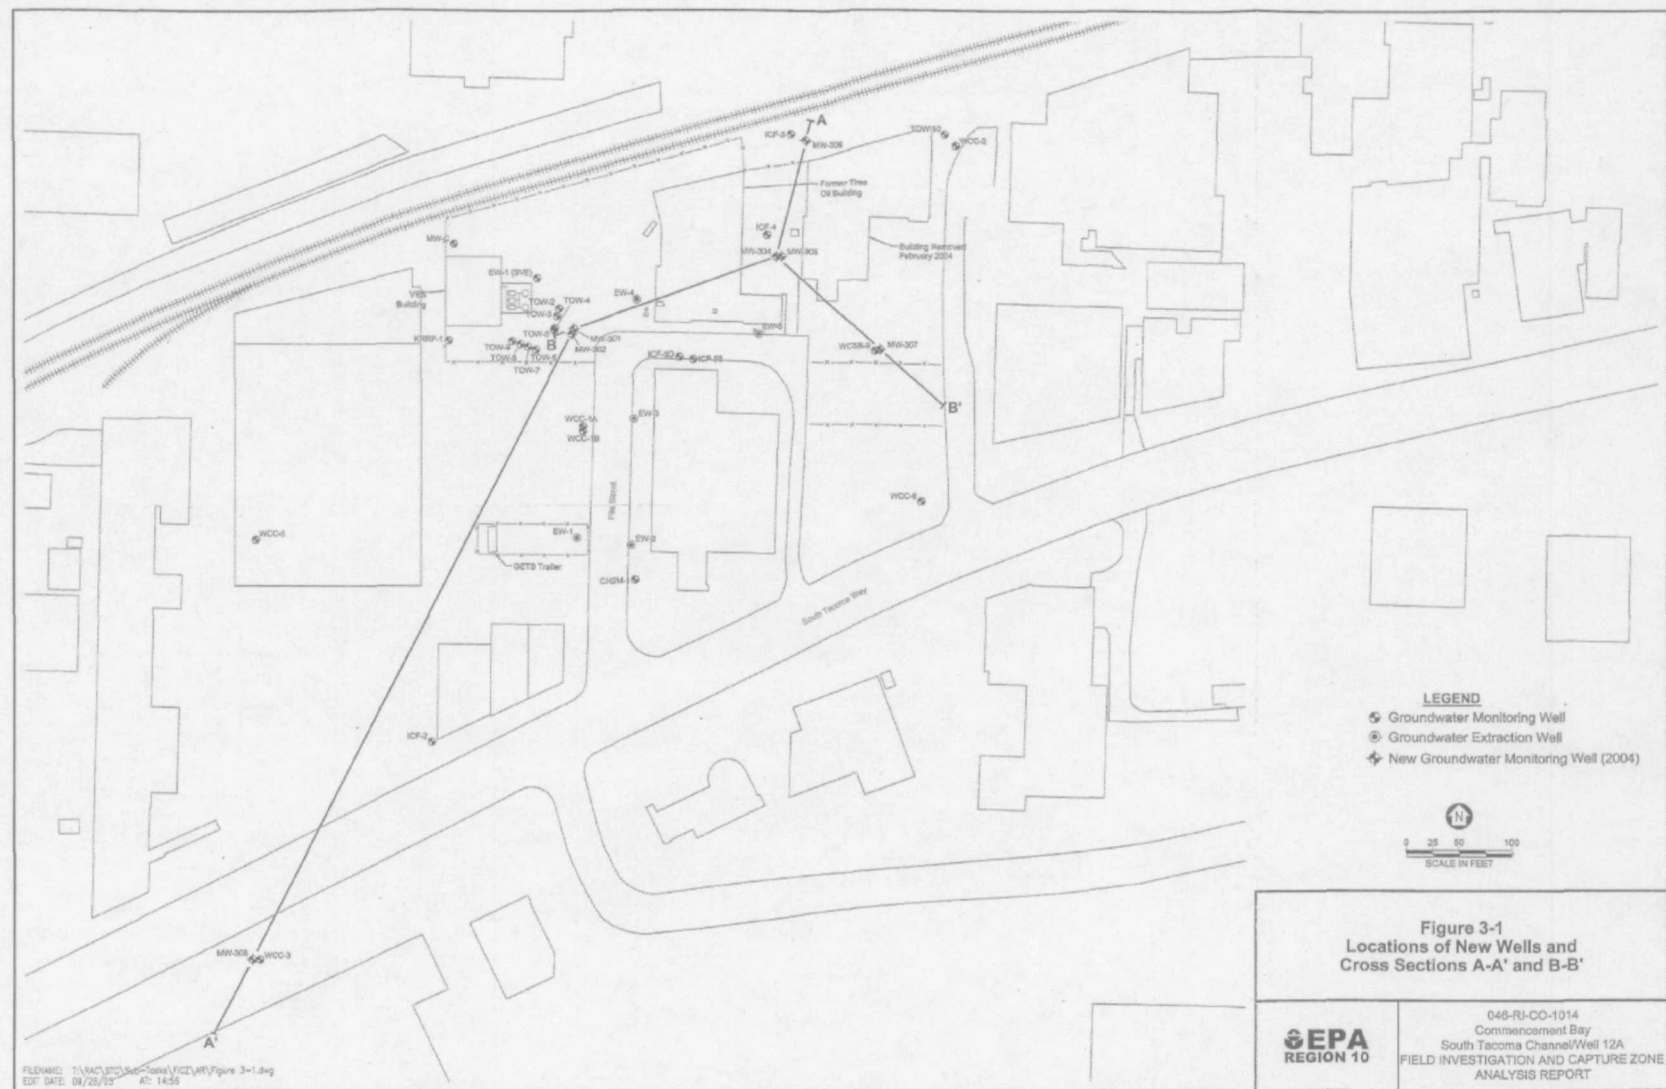
Figure 1-5. Cross Section Location, Well 12A

**5. Soil and Product Data.** Soil samples were most recently collected during installation of new wells during the CZA study (Figure 1-5). This section summarizes these results to provide a current understanding of the soil contamination known to be left in place. Additional soil data have historically been collected but are not discussed in detail in this document. All historical data are currently being used to develop a comprehensive conceptual site model for future remedial option evaluations. A summary of the soil data from the well installation samples are provided below.

smear zone near the water table where it coats soil particles and partially fills voids in the soil. The NAPL is known to contain high concentrations of chlorinated solvents. High soil concentrations of chlorinated solvents were found at depths exceeding the historical low ground water level of 40 feet below ground surface. A conceptual site model (CSM) depicting generalized contaminant sources at the site is presented on Figure 1-9. More detailed analysis of the soil concentrations throughout the site is currently being conducted to refine the CSM.

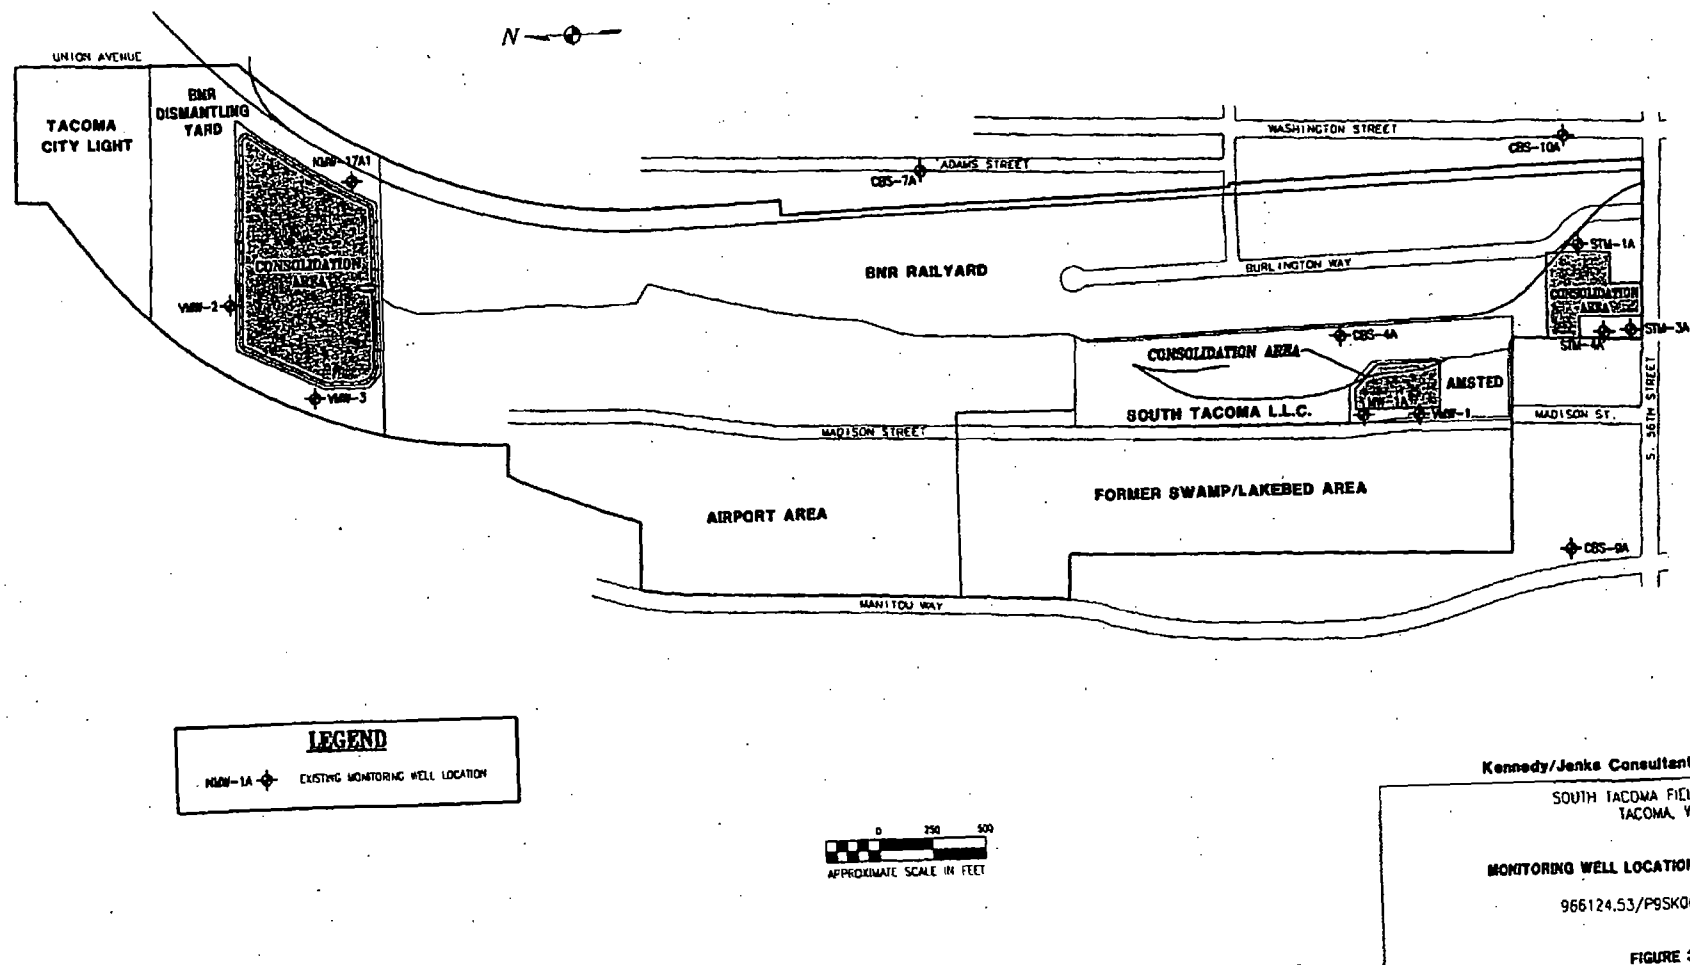
Figure 2-6. South Tacoma Field Monitoring Well Locations

STF ground water monitoring data are presented in Attachment 2-2 and well locations are shown on Figure 2-6. Concentrations of total lead in all STF wells have been below the cleanup levels since 2002 indicating that lead is not impacting site ground water. As stated above, monitoring well STF-1A has not been sampled since October 2001 due to damage. Even though STF-1A did not contain lead concentrations above the cleanup level prior to the damage, this well should be replaced and sampled to verify that ground water to the east of the southern consolidation area has not been impacted.

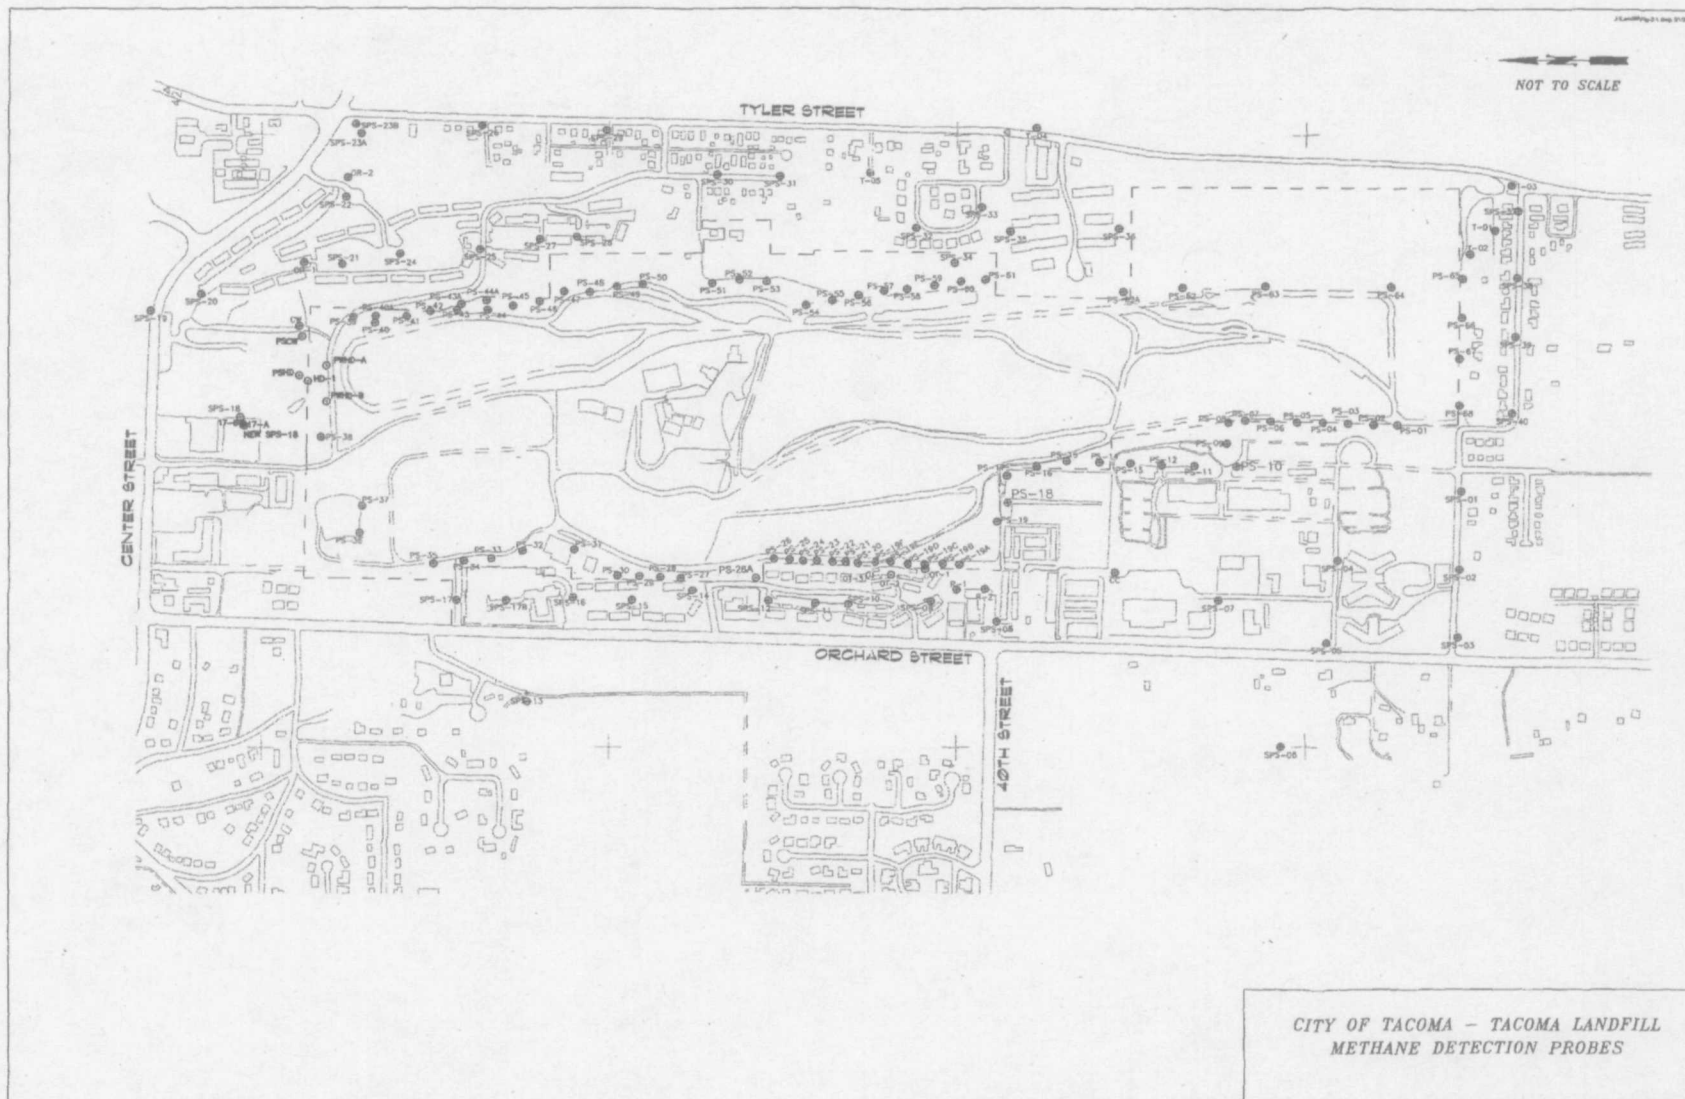
Figure 3-5. Tacoma Landfill Gas Monitoring Probe Locations

**2. Landfill Gas Management.** A landfill gas management system was installed in several phases starting in 1986. The system currently consists of over 300 gas extraction well stations each consisting of one to four wells completed to various depths, piping for transferring the collected gas to a flare station where the gas is destroyed, and the flare station. It is being expanded into the Central Area as areas get filled to final grade. See Figure 3-4 for the location of the gas extraction wells. The effectiveness of the landfill gas management system is evaluated through regular monitoring of gas probes situated within and adjacent to the Landfill for pressure (vacuum) and methane concentrations. VOCs are not currently analyzed as part of the program. The gas monitoring system includes approximately 78 gas monitoring probes around the perimeter of the Landfill and an additional 56 off-site probes up to 1,000 feet from the edge of the Landfill. Each probe consists of one to five monitoring ports completed to various depths. See Figure 3-5 for the location of the gas monitoring probes.
